Manhole Inspection Summary

Manhole # S33E__015MH

Inspection ☐ Is Incomplete Rating: **5) Immediate Attention Required**

Location Address: **301 w lexington st**

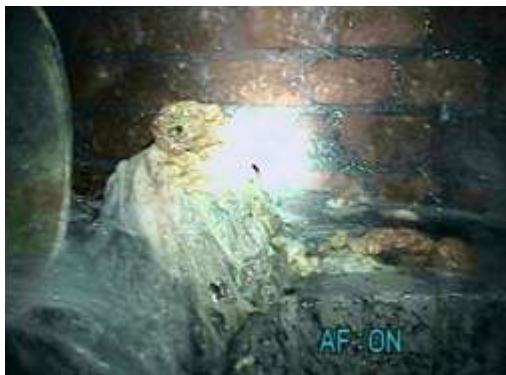
Defect 3

Condition: ☐ Sound ☐ Cracked ☐ Root Intrusion ☐ Deteriorated ☐ Leaks ☒ **Debris**

bench debris

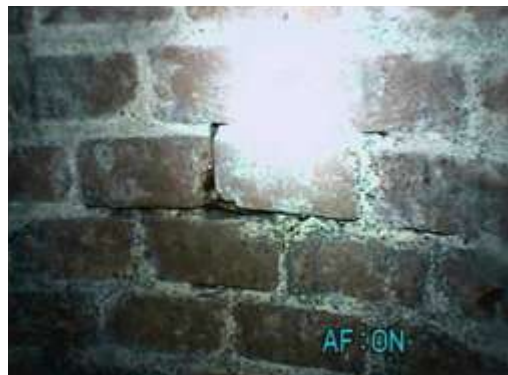
Defect 4

Condition: ☐ Sound ☐ Cracked ☐ Root Intrusion ☒ **Loose Brick** ☐ Deteriorated

loose brick in barrel

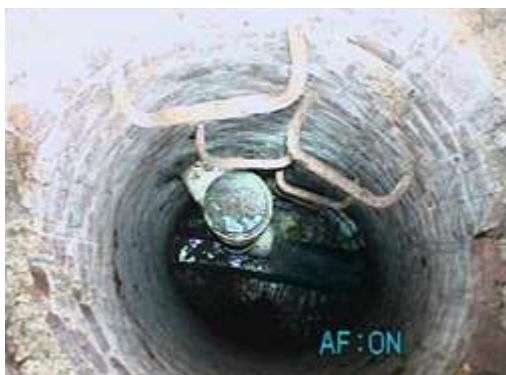
Defect 2

Count: **6** Missing: **0** ☒ **Corroded**

steps

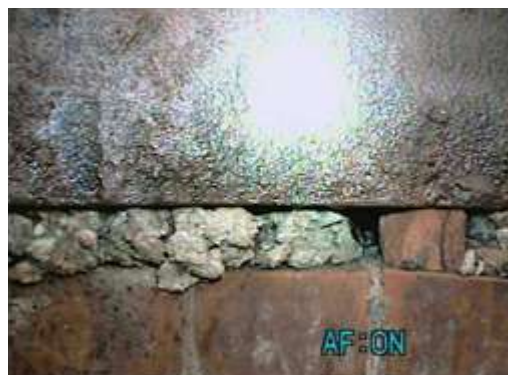
Defect 1

Comments **Cover was sticking up before we started & wont go all the way down**

Condition: ☐ Sound ☒ **Cracked** ☐ Root Intrusion ☒ **Loose Brick** ☐ Deteriorated

cracked chimney, loose bricks, frame adj
